Rock Art Management and Landscape Change: Mixed Field Assessment Techniques for Cultural Stone Decay

Rock Art Management and Landscape Change:
Mixed Field Assessment Techniques for Cultural Stone Decay

A dissertation submitted in partial fulfillment
of the requirements for the degree of
Doctorate of Philosophy in Environmental Dynamics

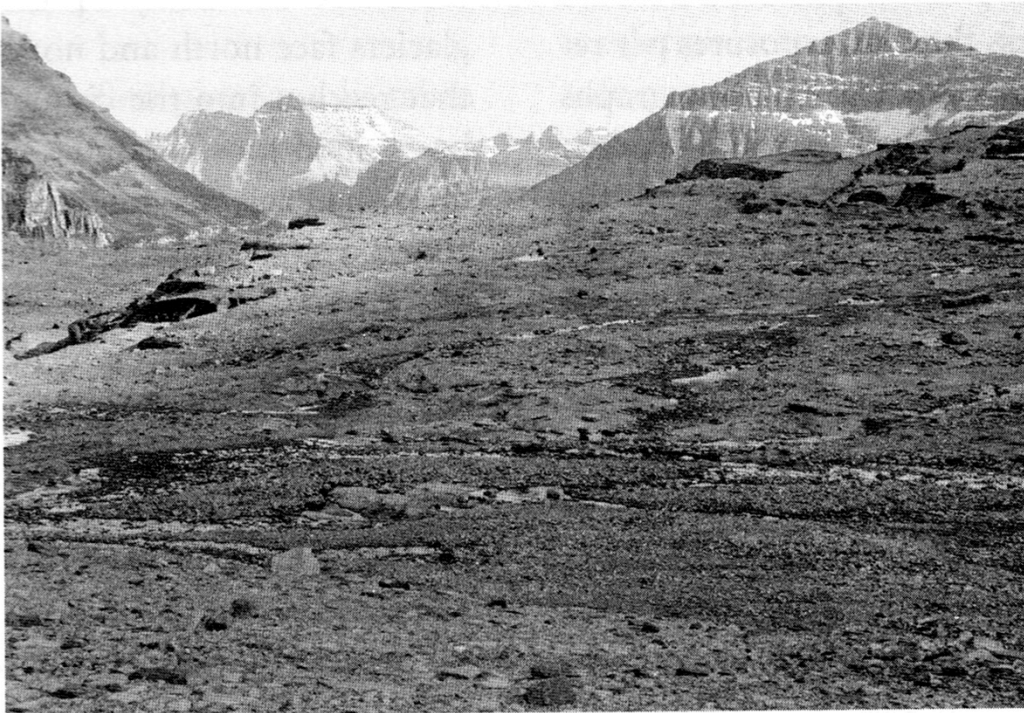
Figure 3.3 – Example of repeat photography in glaciology. This particular graphic shows the change of the Glacier Ice Cave from A: 1932 to 1988. Photos by G.A. Grant and J. DeSanto in Fagre and McKeon (2010).

in a marginalized environment. On the other end, repeat photography comparing historic and modern landscapes are also valuable, such as the National Park Service's historic repeat photography project identifying changes in glaciers in Glacier National Park in Montana, which display a startling recession and disappearance of many park ice masses (Figure 3.3)(Fagre & McKeon, 2010). Beyond temporal ranges, depending on the purpose of the study and quality of existing photos, techniques for finding image positions and insuring repeat accuracy, along with post-field analyses, vary considerably.

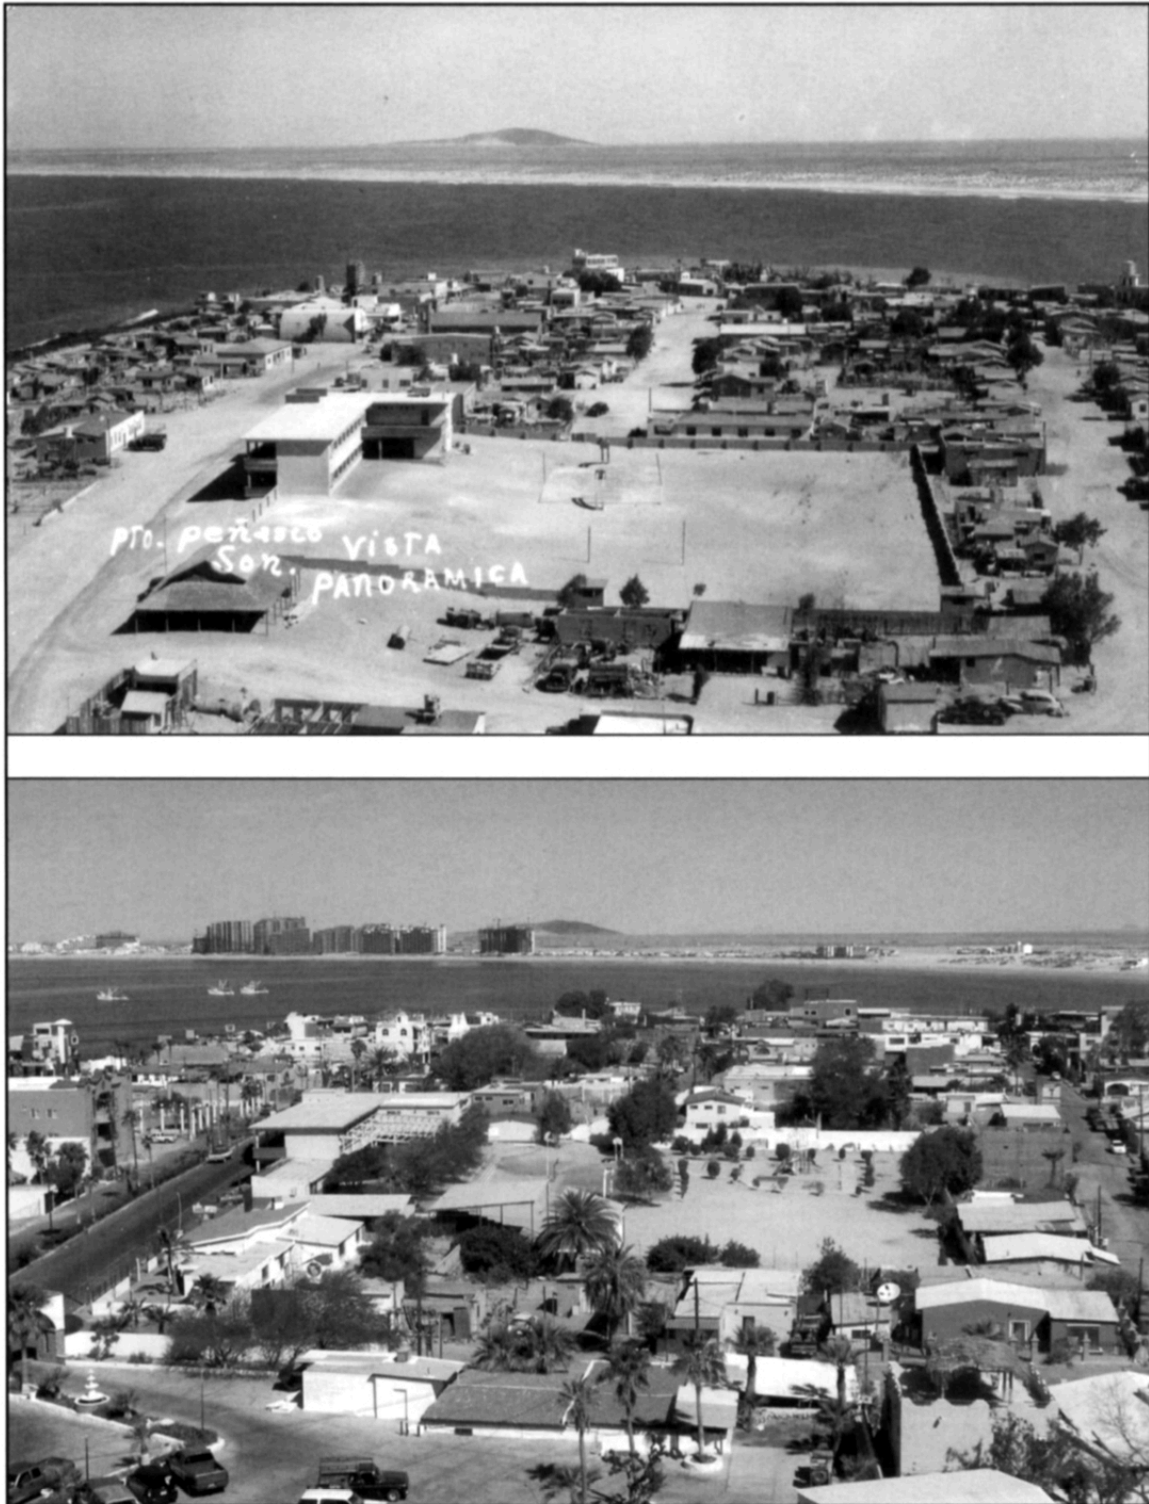
Figure 3.4: Repeated photographs of a small residential area in Puerto Peñasco. A small schoolyard and church are visible in the center of both photos. Major developments include improvement of roads and the construction of large resorts and condominiums in the background on the other side of the water. Vegetation and general infrastructure also show advancements. Images from Finn et al. (2009).

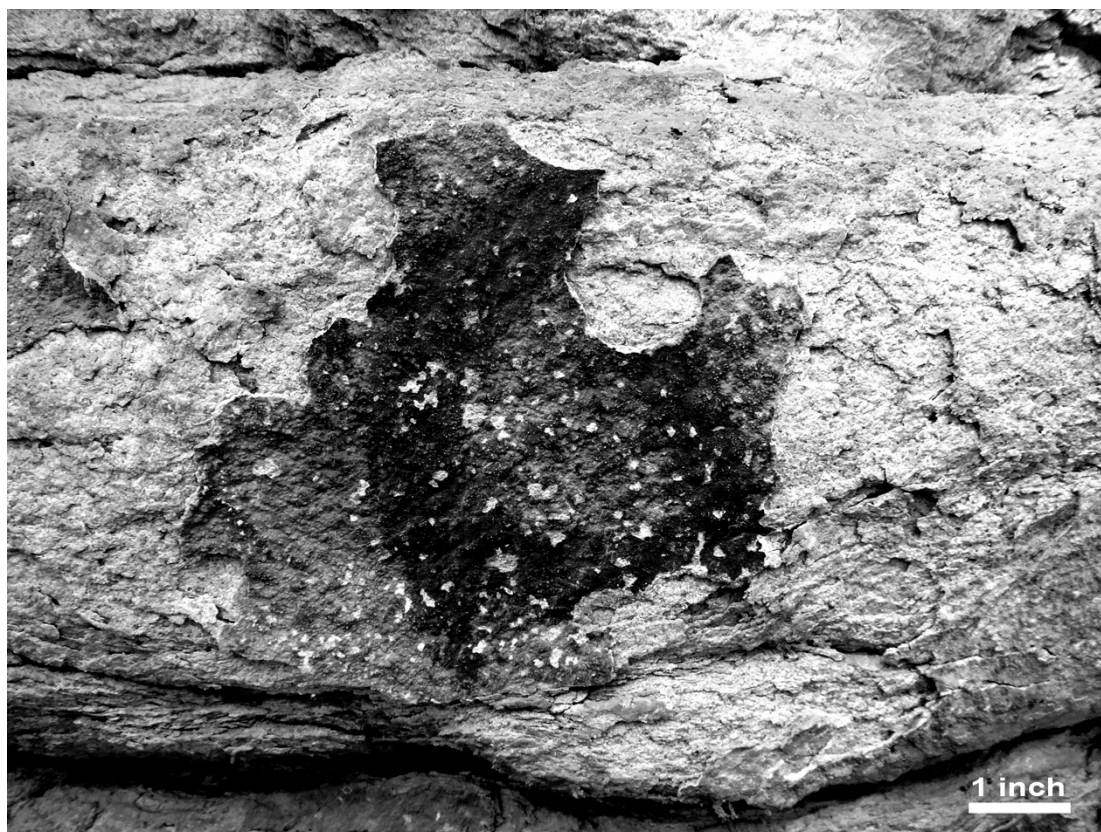
Figure 4.8: Close up view of intense weathering rind development and flaking of a single red circular pictograph at the Putnam Rock Shelter. Photograph by author.

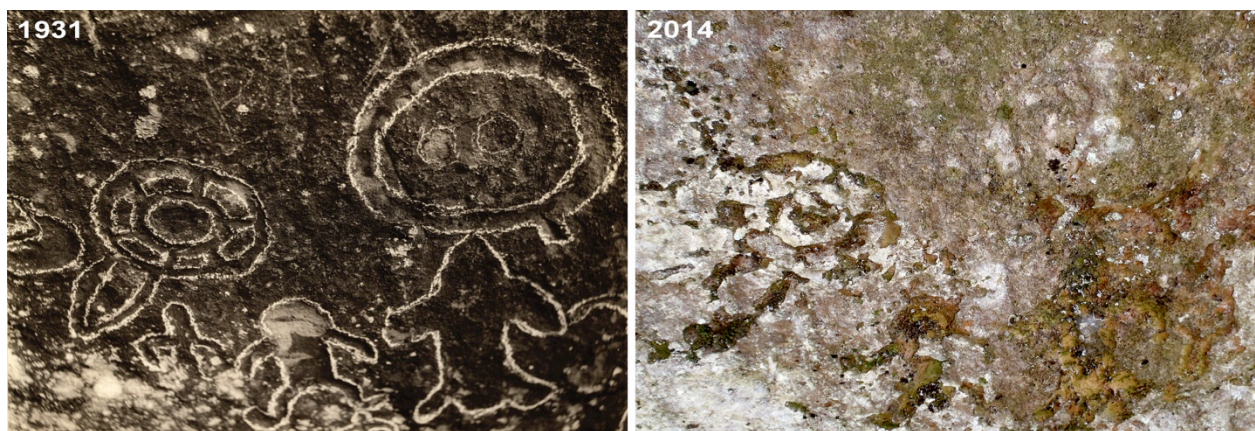
Figure 4.12: Left side: 1931 photograph of the upper right section of Panel 4 at Edgemont Rock Shelter with permission of the Arkansas Archeological Survey. Right side: Repeat photograph by author, 2014.

a couple of anthropomorphs (Figure 4.12). The small half moon-shaped outline on the far left of the image represents the beginning of the main subject of the second repeat photograph of left end: what appears to be a long-bodied quadruped above a small lizard and surrounded by other indistinguishable motifs (Figure 4.13). The most obvious change over time is the development of widespread lithobiont colonies now covering the majority of the panel. Although it is suspected the historic motifs would not be as clear without chalking, the panel surface in the older image noticeably clearer of lithobionts, particularly around the glyphs themselves and around the center of the photographs—the dramatic growth of the white lichen is the most noticeable. While the sepia coloration of the historic image may obscure evidence of mosses or other bio-coatings, the texture and uniform appearance of the panel surface suggests that at least some of host stone was still exposed in 1932—a statement that cannot be made for the modern repeats which are completely consumed by lithobionts. Not only are the petroglyphs now covered and harder to see, but, the biological degradation of the stone surface is also apparent in the repeat photographs, particularly in the more detailed elements such as the feet of the quadruped in figure 4.13 and the inner components of the left circular design in figure 4.12. With this decay showing through the biological coatings, it is suspected that the removal of the lithobionts would only cause further damage—which is often the case with lithobiont overgrowth (Whitley, 2001).

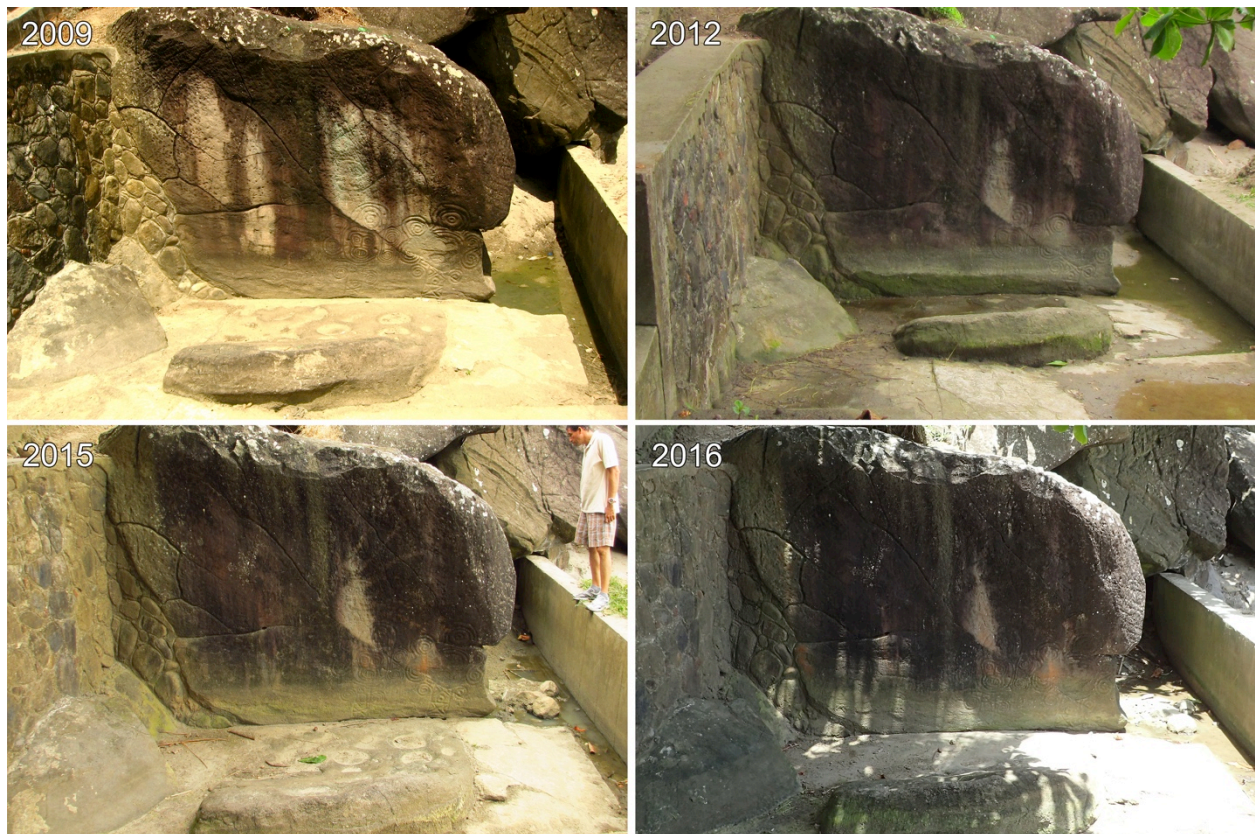
Figure 5.6: Repeat photographs of Panel 1 at Duquesne Bay from 2009 to 2016. All photographs provided by Casey Allen except 2016 (by author).

Representing the setting of the two primary panels at Duquesne, the contextual repeat photographs for the main boulder provide a longitudinal view of the retaining wall's impact on the site's stability (Figure 5.6). Time of day and changes in shadows from surrounding foliage may account for

some visual difference, but wicking, sedimentation, run off/abrasion, and stagnant water are only some of the issues identified in these photos. To determine the visual extent to which these issues may have impacted the individual motifs, more in-depth repeat photographs were taken of the primary petroglyphs on each panel.

Up close repeat photography for both panels one and two illustrates many of the concerns already acknowledged during the RASI analysis, such as changes in lithobiont activity and loss of petroglyph detail. Panel one, with the added advantage of a longer displayed timeline, demonstrates the dramatic detail loss of the right decorative anthropomorph due to increased granular disintegration, flaking, and lithobiont activity (Figure 5.7). Additionally, the RASI-identified differences in rock coating are revealed as not only a general darkening of the stone surface, but also the development of different types of coatings, some beneficial, such as the dark stone patina, and others potentially damaging, such as the spreading orange algae in the center left of the 2016 photograph.

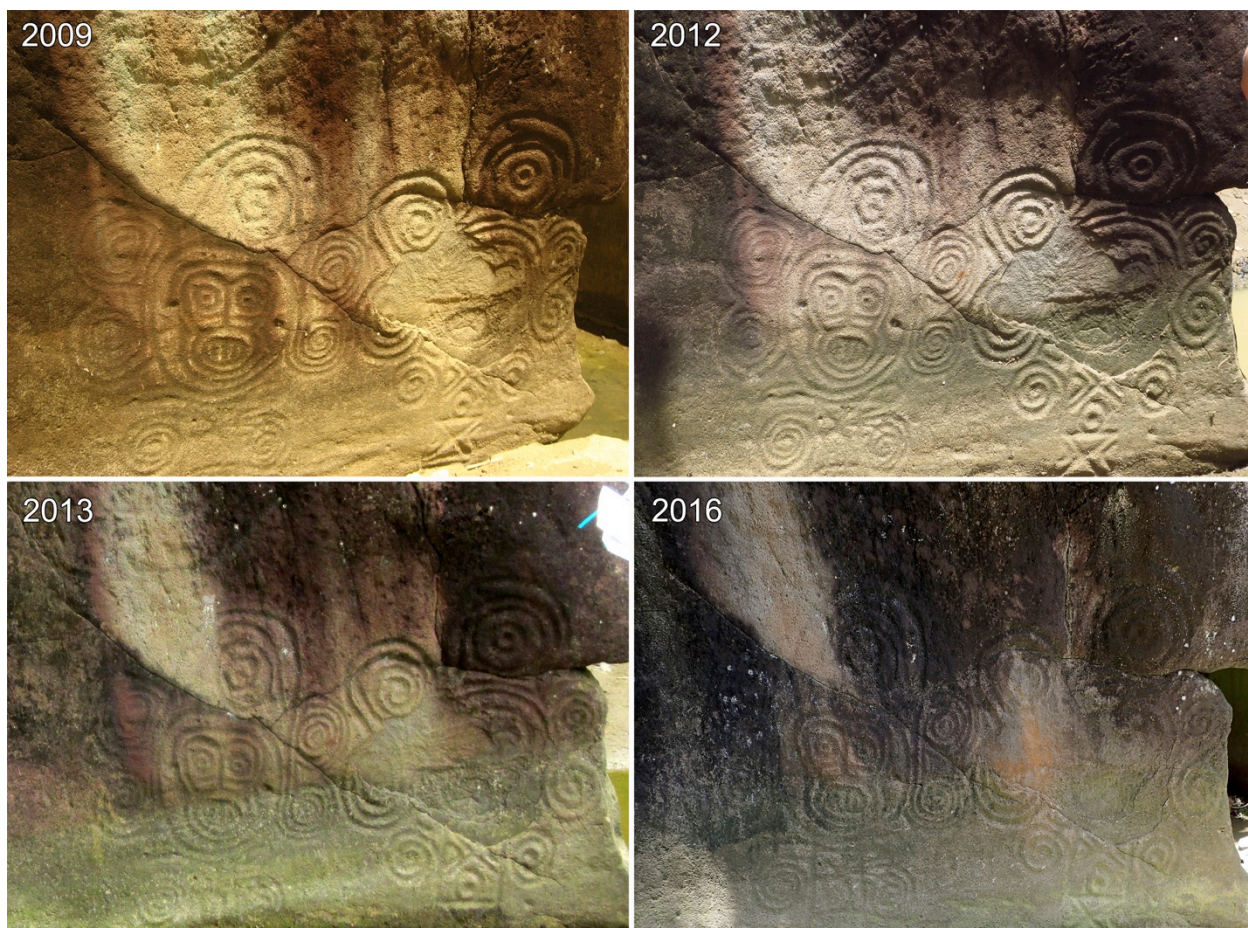
Figure 5.7: Close up repeat photographs of the two primary motifs on Duquesne Bay Panel 1 from 2009 to 2016. All photographs provided by Casey Allen except 2016 (by author).

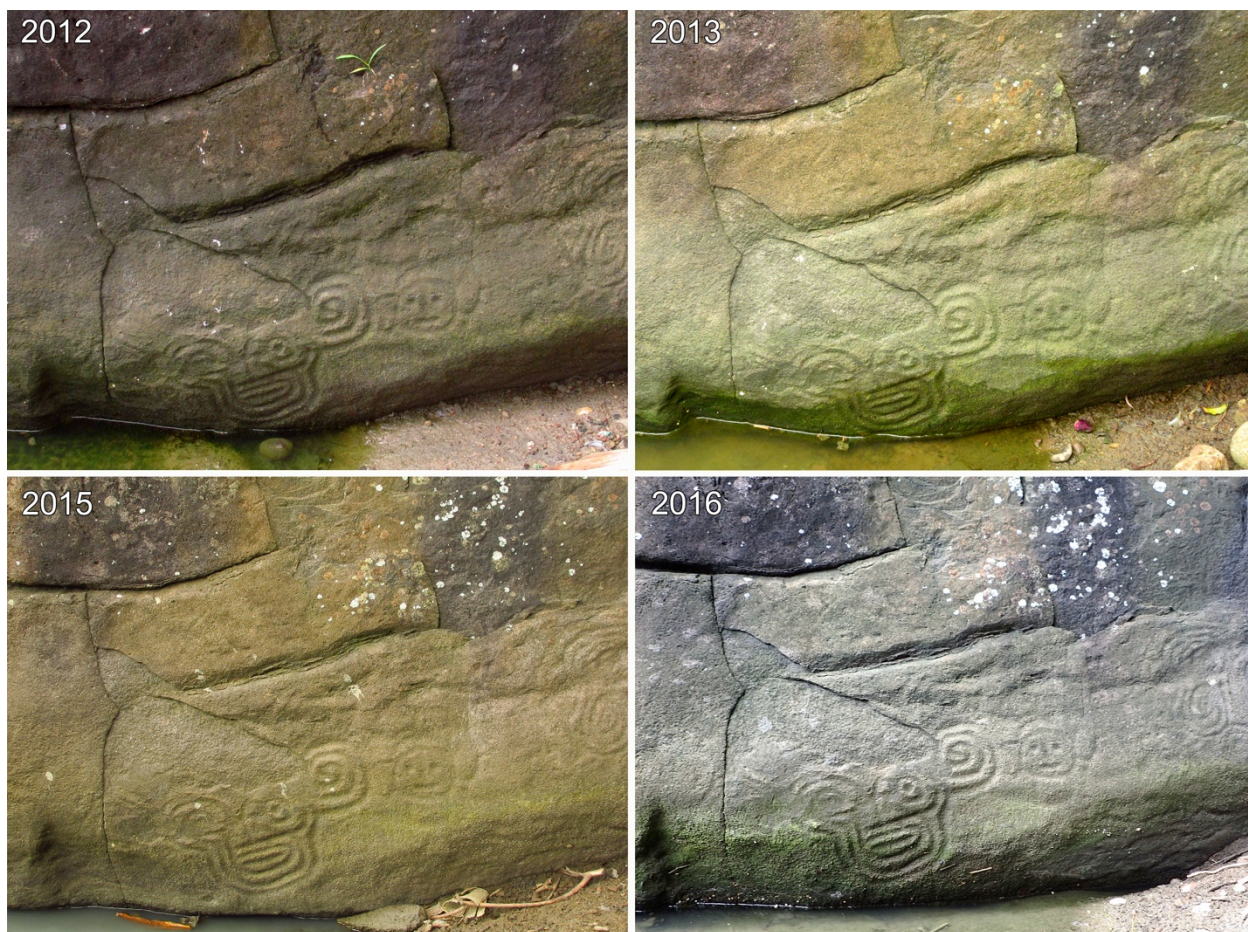
Figure 5.8: Close up repeat photographs of motifs on Duquesne Bay Panel 2 from 2012 to 2016. All photographs provided by Casey Allen except 2016 (by author).

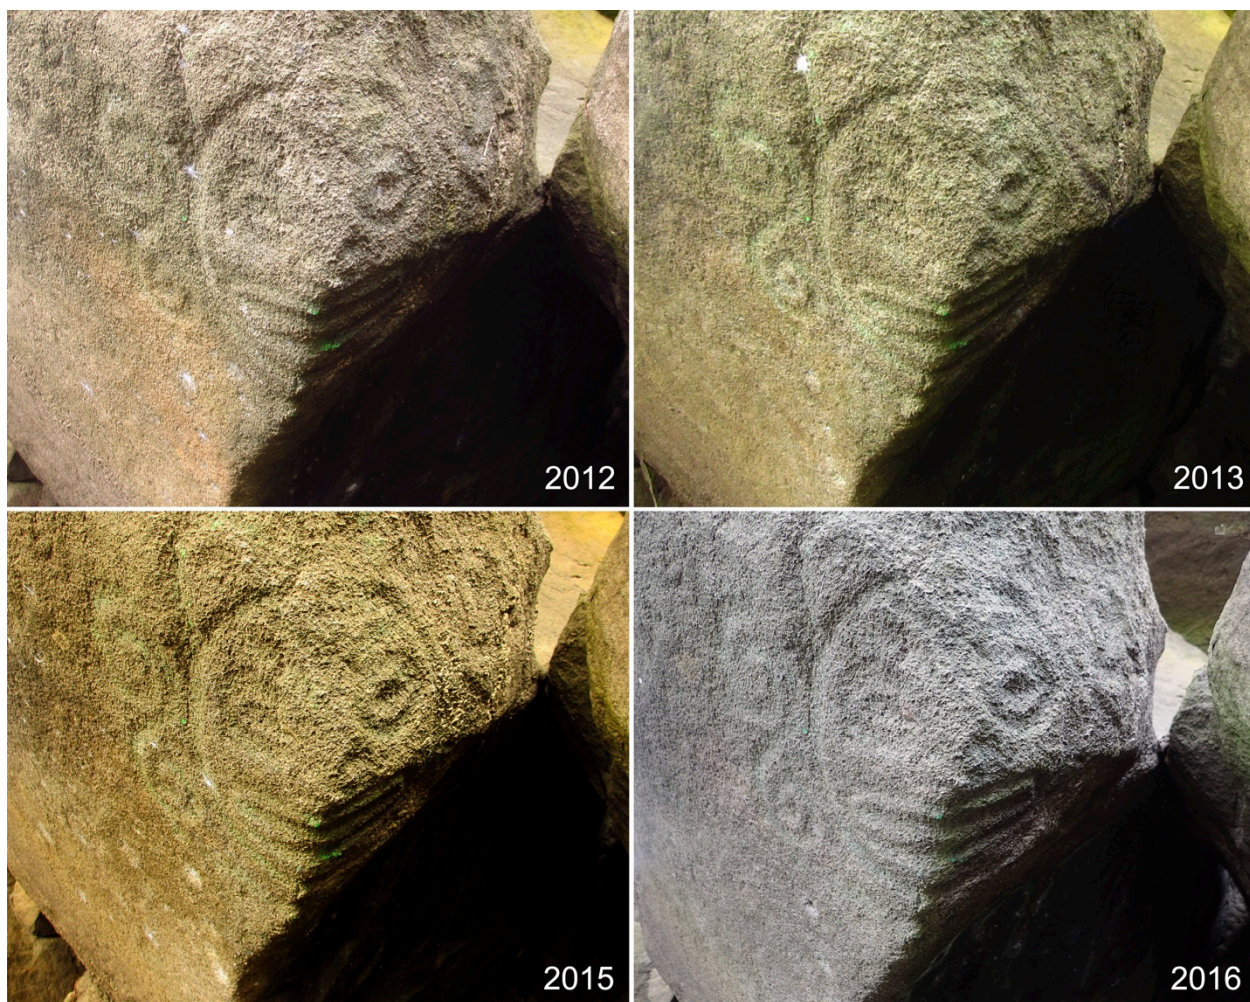
Figure 5.9: Close up repeat photograph of the bi-angle face on Duquesne Bay Panel 3 from 2012 to 2016. All photographs provided by Casey Allen except 2016 (by author).

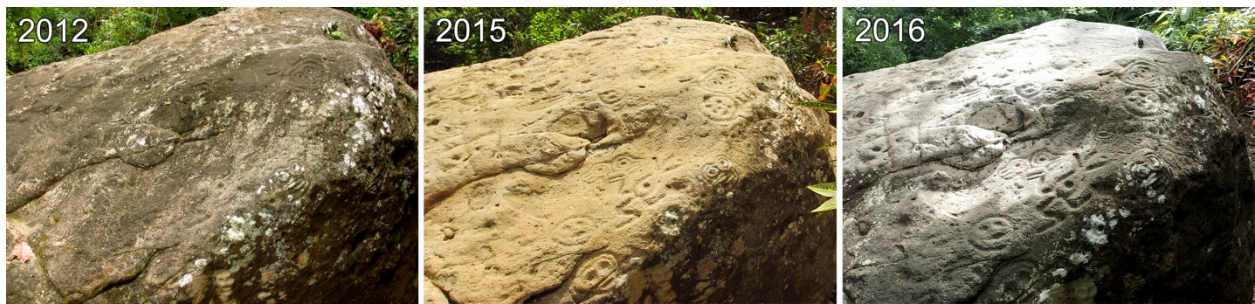
Figure 5.13: Repeat photographs of the upper section of Mount Rich Panel 7 from 2012 to 2016. The most noticeable change is in panel color and the clarity of motifs. For example, the petroglyph resembling a bowing anthropomorph in the lower center of the images is very obscured in the 2012 photograph, clear in the 2015 image, and still clear, despite algal growth, in the 2016 image. 2012 and 2015 photographs by Casey Allen, 2016 image by author.

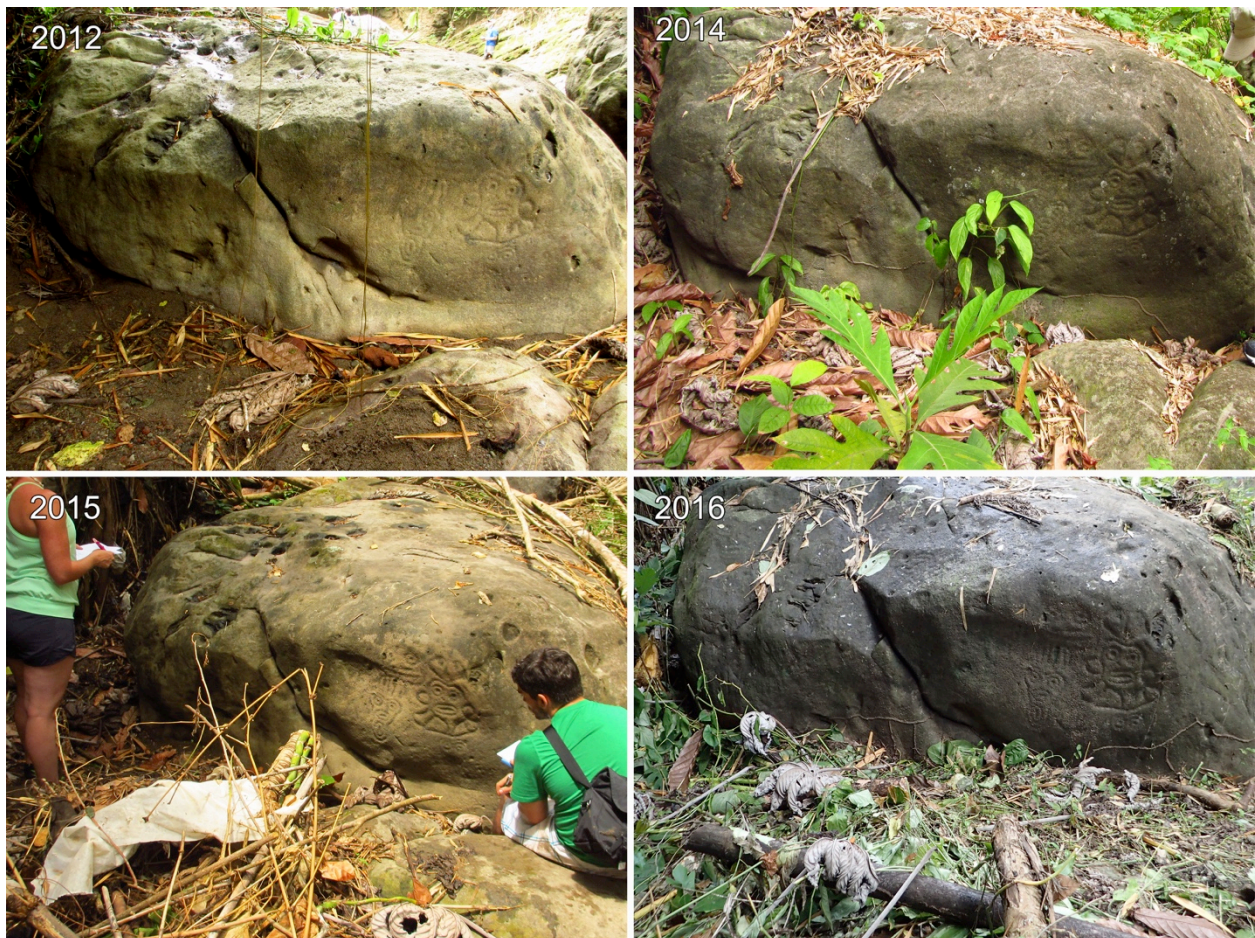
Figure 5.14: Repeat photographs of the small boulder containing Mount Rich Panels 2 and 3 from 2012 to 2016. Plant growth around the boulder and rock coatings are the most obvious changes among the images. All photographs by Casey Allen, except 2016 (by author).

Separate from the primary boulder and displaying some of the only improved RASI scores post-cleaning, the repeated photographs of panels two and three highlight visual changes that may have impacted the panels' scoring (Figure 5.14). For example, the large pill of debris in the foreground of the 2015 and 2016 images may represent a problem for panel two but not three, which is situated on the upper-left side of the boulder beyond the reach of moving debris. Additionally, the uncharacteristically lighter color and deepening of the petroglyphs on panel two in the 2015 image compared to panel three and previous years validate the speculation that the panel had been scrubbed—initiating significant textural changes visibly impacting the panel's stability in the post-clean photo, especially around the lower-left motif where cleaning seems the most concentrated. The most significant visual change, however, is one common among the repeated photographs for the site: the development of a dark algal coating in the 2016 post-clean photographs (figure 5.15). The cause and impact of this coating is unknown and will require further examination.

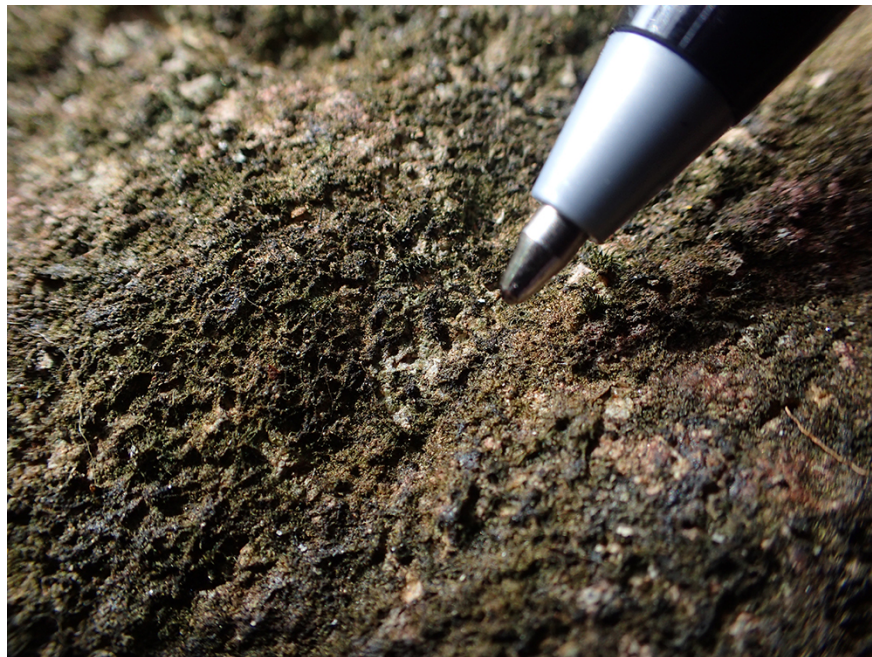
Figure 5.15: macroscopic photograph of the algal coating found on most panels at Mount Rich. Further research is necessary to determine species or morphology of this coating. Its emergence and prolific proliferation over the course of a single year is a significant landscape change that deserves additional attention in future examinations of the site. Photograph by author, 2016, shown in color for better identification of coatings.

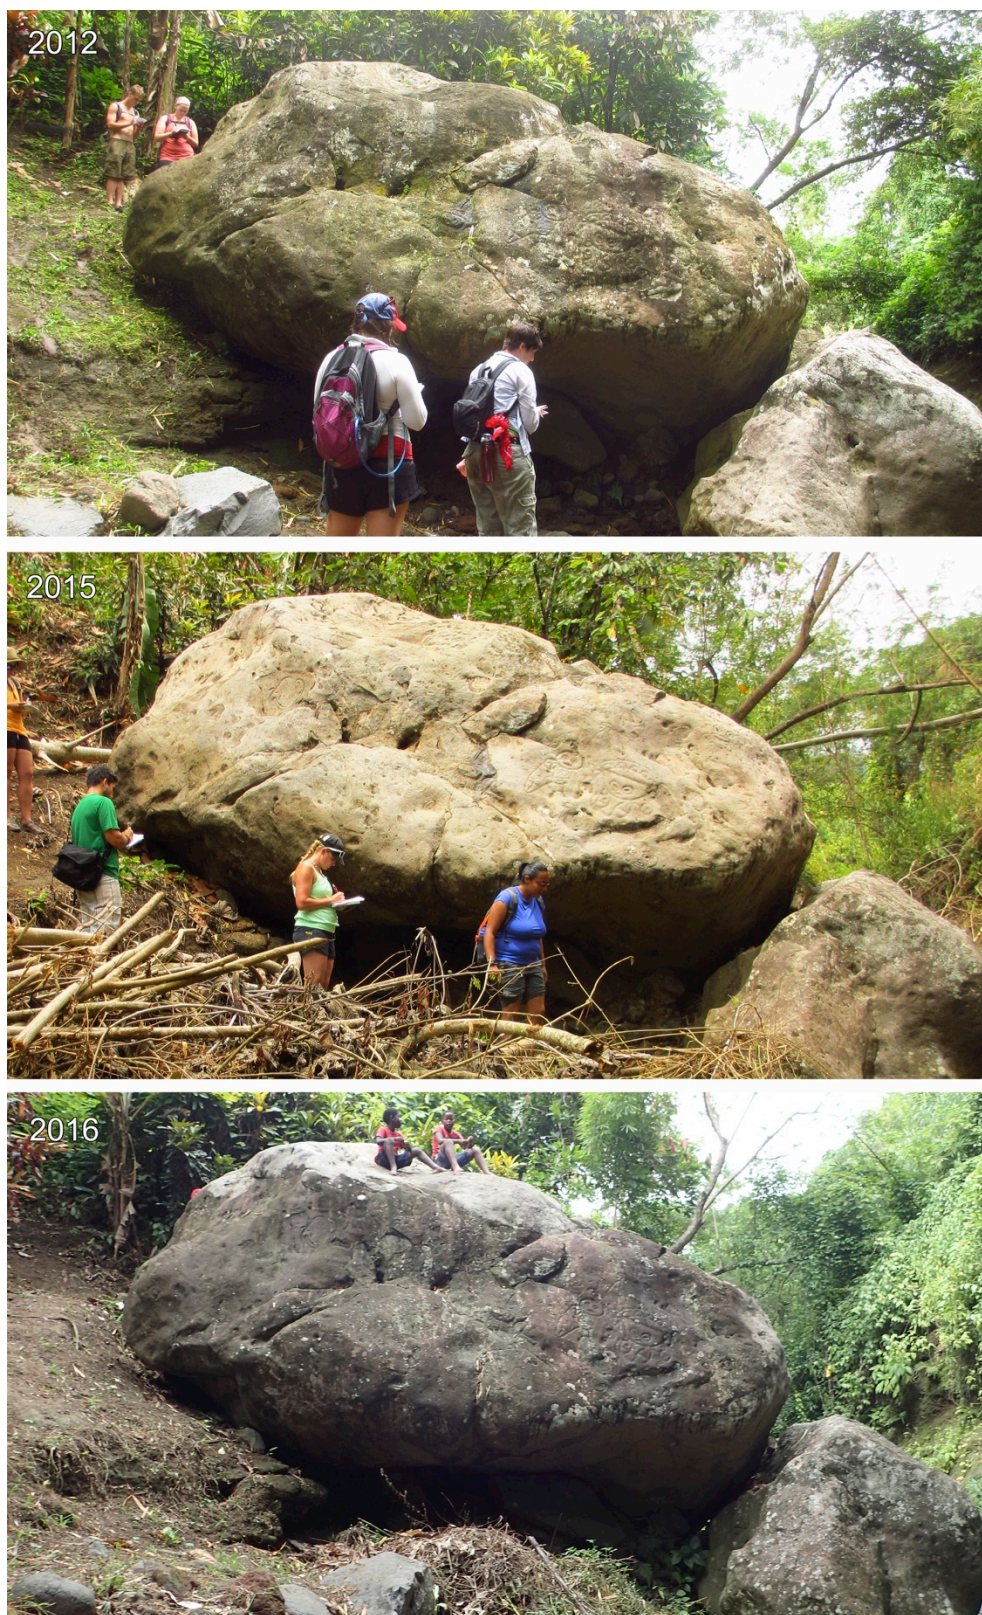
Figure 5.16: Repeat photographs of Mount Rich Panel 4 from 2012 to 2016. Rock coatings and surrounding landscape display the most change. 2012 and 2015 photographs by Casey Allen, 2016 by author.

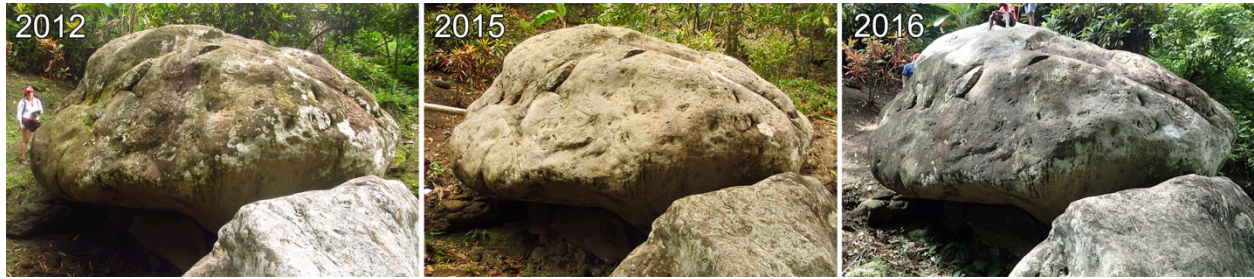
Figure 5.17: Repeat photographs of an alternate view of Mount Rich Panel 4 and part of Panel 9 from 2012 to 2016. Rock coatings and surface texture are the most visible differences over the last few years. 2012 and 2015 photographs by Casey Allen, 2016 by author.

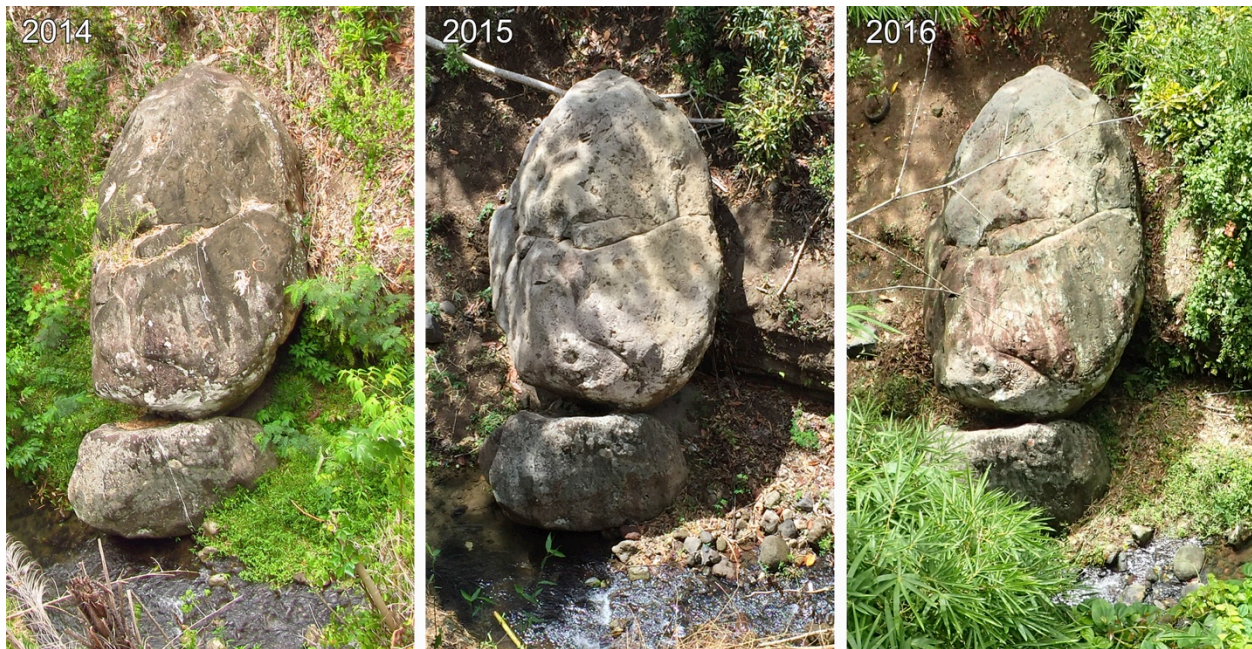
Figure 5.18: Repeat photographs of Mount Rich Panel 9 from the road, 2014 to 2016. Image quality is not as clear for these images, as at least one photograph was taken on a smart phone. Vegetation and rock coatings are among the most visible changes. 2014: Casey Allen, 2015 Cayla Kennedy, 2016: Author.

Panel nine, with the most famous and well-known petroglyphs at Mount Rich, is one of the only panels visible from the road, so its repeat photographs were taken from this vantage point (Figure 5.18). When seen from above, contextual changes such as vegetation/debris removal as well as the boulders proximity to the stream are relatively obvious. The plant growing in a fissure on panel four in 2014 has been removed, as has the fallen tree from 2015. Small debris and leaves around the base of the boulder hint at the floods that frequent the St. Patrick River. In terms of panel nine specifically, located at the base of the large boulder, the scrubbing of the stones and removal of rock coatings seen in the 2015 image increase the motifs' clarity, albeit while simultaneously decreasing its stability. The 2016 post-clean image shows a more uneven algal coating than those found on the more vertical panels at the site. The streaky patterns of the coating may suggest rainfall or water run off has limited establishing more holistic coverage. Interestingly, however, an algal colony appears to have developed *within* the lines of the Sun God glyph—making it even more visible from a distance. Also visible from a distance is the aesthetical disintegration of the Sun God—decreasing detail sharpness and appearing “woolly” or generally less stable through the years. On the top end of the boulder, the stark white/grey of raw stone remains through the 2016 image, potentially clarifying the continuously increasing RASI scores for panel six, which is located near this section of the stone.

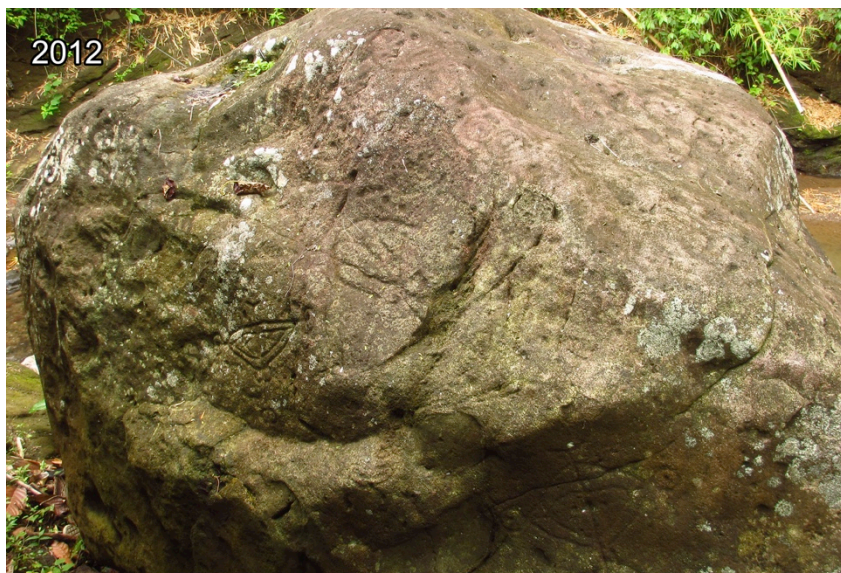
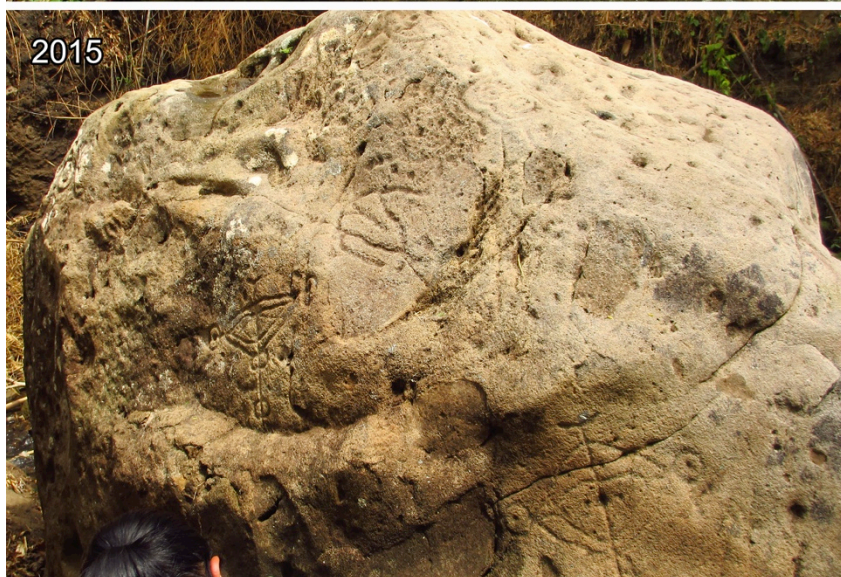
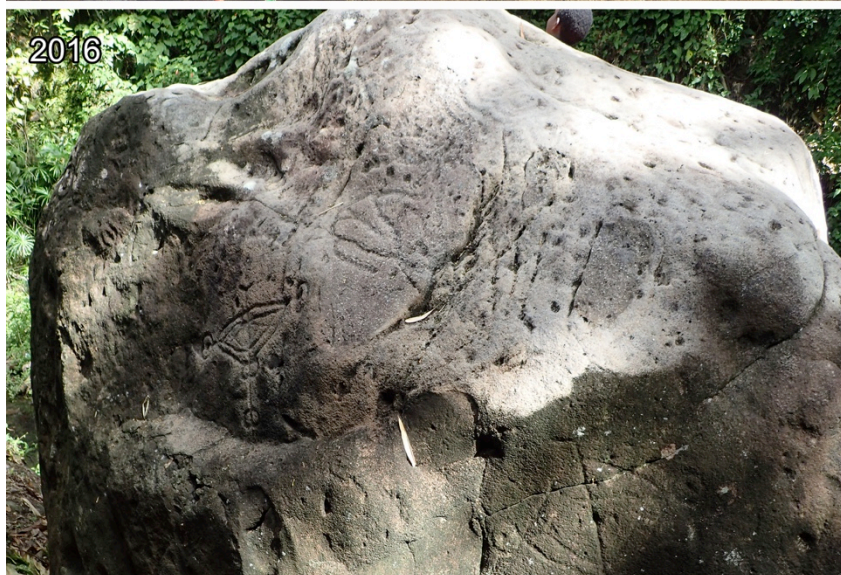
Figure 5.19: Repeat photographs of Mount Rich Panel 6 from 2012 to 2016. Panel 6 is unique as it is located on the only area of exposed pillow basalt on the main boulder. Coloration and glyph clarity are a few of the more obvious changes. 2012 and 2015 photographs by Casey Allen, 2016 by author.

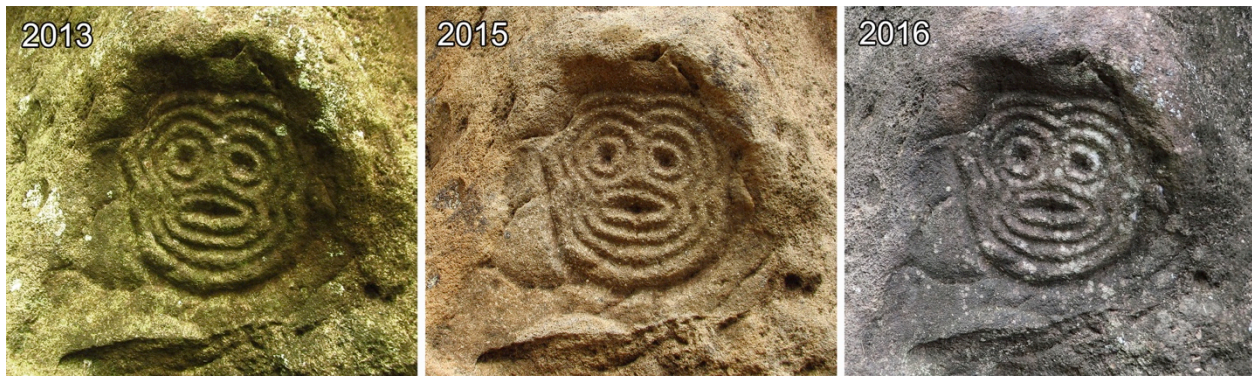
Figure 5.20: Repeat photographs of the deeply incised face on Mount Rich Panel 5 from 2013 to 2016. Panel 5 was among one of the more heavily scrubbed panels, as seen in the 2015 image, and has since been mostly covered by the dark algal coating found on most panels in 2016. 2013 and 2015 photographs by Casey Allen, 2016 by author.

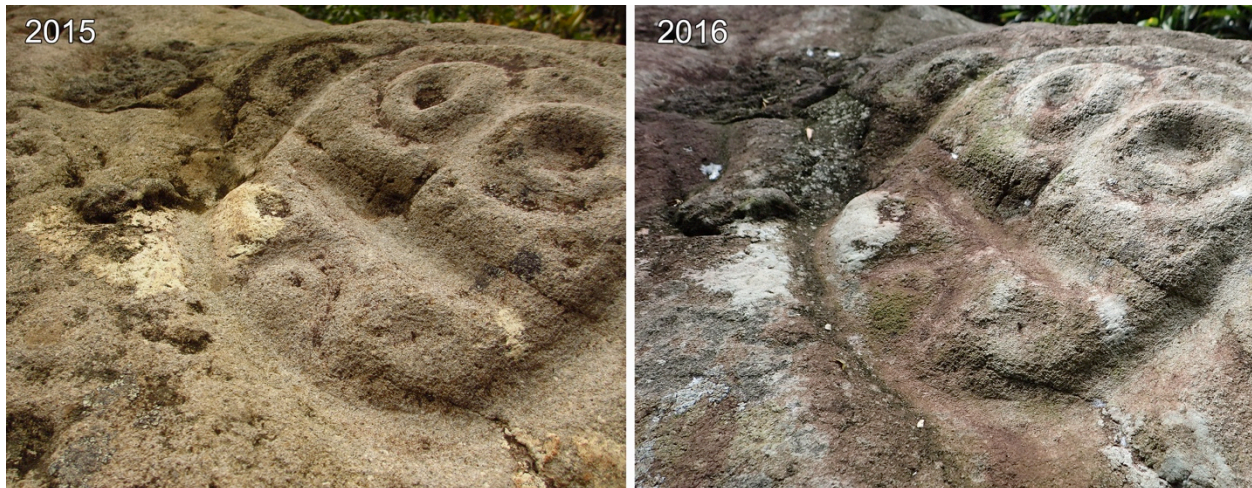
Figure 5.21: Close up repeat photographs of a scrubbed face on Mount Rich Panel 9 from 2015 and 2016. The scrub line running directly through the lichen colony on the left side of the images illustrates how the local volunteers paid special attention on the individual glyphs. Since the cleaning, new lichen and mosses appear to have inhabited some of the scrubbed surfaces within the petroglyph. Photographs by author.

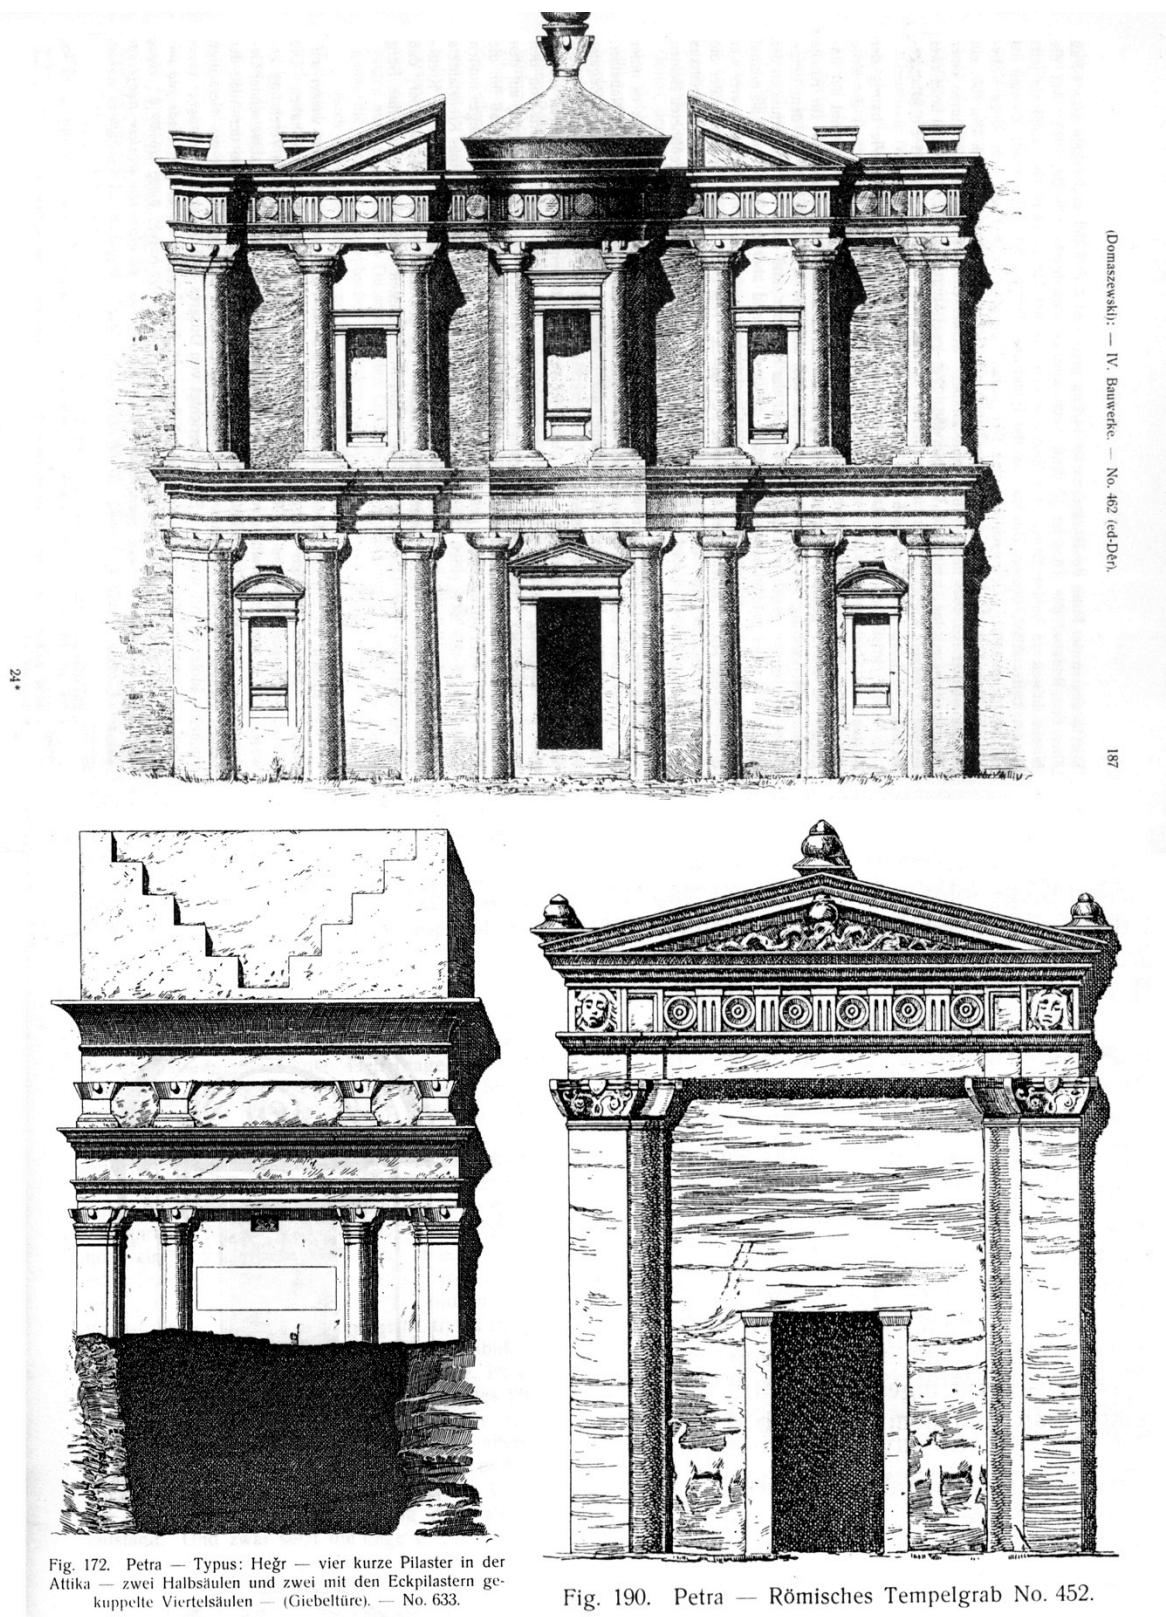
Figure 6.3: Conceptual sketches of the three assessed monuments from Brünnow et al. (1905)—one of the first extensive surveys/publications addressing Petra.

While CSSI shares most of RASI’s strengths and weaknesses as a research tool (see Chapter 3.2.1 for review), there are a few new challenges and benefits that come with CSSI specifically. For example, Unlike RASI, CSSI compares current conditional statuses against assumed non-decayed baselines, since most cultural stone resources were created from “new” material. With RASI, researchers need to recognize that there will be a certain degree of “inherited decay”—rock decay that took place before the rock art was created—in their final scores since most rock art exists on pre-exposed surfaces. In contrast, the “virgin surfaces” of built monuments and building facades foster the assumption that all decay present has occurred after the completion of the resource. This assumption provides researchers with a controlled timeline of decay—allowing them to estimate factors such as rates of decay and date of decay initiation, which are much more difficult to calculate in natural settings. That said, the possibility remains that assumed baselines can skew results if the original surface was different than presumed (e.g. if stone dressings imitating textural deterioration were applied intentionally). In surveyed sites, such as Petra, baselines could be structured after archaeological records or sketches created by early scholars in the region (e.g. Figure 6.3).

definition is unique to CSSI, as it allows researchers to put an emphasis on key features of whatever cultural stone is being assessed. The third and smallest monument, the Lion Triclinium, was separated into 12 panels, including 2 contextual panels and a small icon niche to the left of the main monument. Similar to the Turkmanyyia Tomb, the Lion Triclinium was divided by general features but then additional panels were dedicated to specific elements unique to the monument: two carved lions on either side of the tomb entrance and two intricately carved faces in the monument's pediment, all assessed individually.

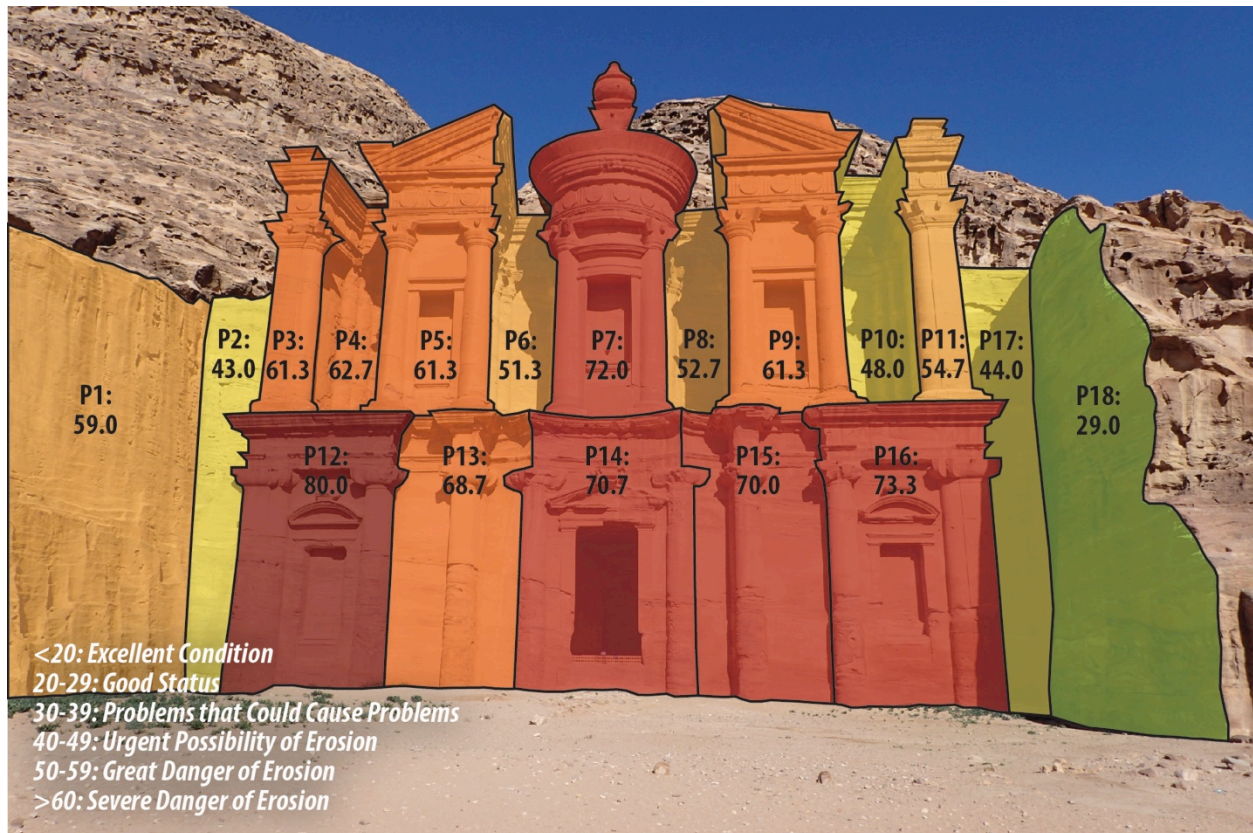
Figure 6.5: The different CSSI panels and scores for the Deir. Colors coordinate with degree of degradation, ranging from green indicating stable conditions to yellow, to orange, to light red, to dark red signifying the highest CSSI scores and most significant decay. Graphic and photograph by author, 2016.
